Post application sheen following the installation of ProJoint™ MAX™, V75-WT™, V400-WT™ & V35-UV™

nexus®
PAVING SYSTEMS

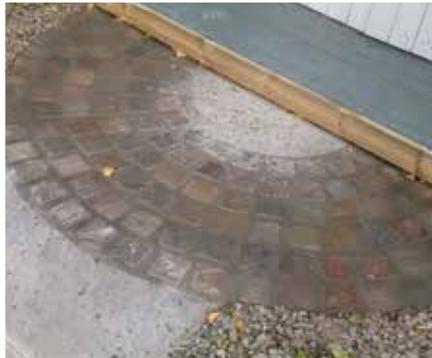
<< *The sheen visible on the newly positioned stone setts and makes them appear darker than the existing paving and brings out their colours (photo taken: 30/9/16).*

The sheen can be minimised by ensuring the paving is adequately prepared and soaked with water prior to brushing/squeegee-ing over the paving. In order to eliminate a 'picture frame' sheen, we recommend that the product slurry be brushed over the full surface of the paving and into joints, not just applied into the joints themselves.

We also recommend using a WET medium soft brush at 45° to the joints to sweep off excess sand - please note that any sand left on the surface will not be easily removed once the product has cured.

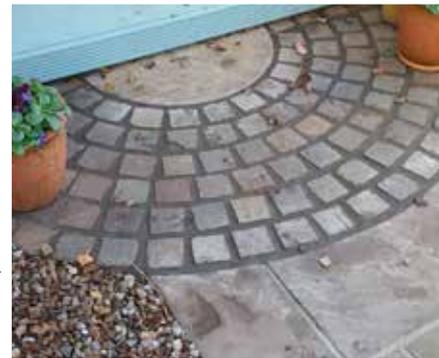
The sheen has disappeared, the new and existing paving look the same (photo taken: 2/12/16). >>
